ALCOA DAM  
NDI No. Pa. - 493

PHASE I INSPECTION REPORT

Alcoa Dam, DNI Number PA-493. Ohio River  
Basin, Little Chartiers Creek, Washington  
County, Pennsylvania. Phase I Inspection  
Report.

PHASE I INSPECTION REPORT  
NATIONAL DAM INSPECTION PROGRAM  
ALCOA DAM  
NDI# PA-493, PENNDER# 63-53

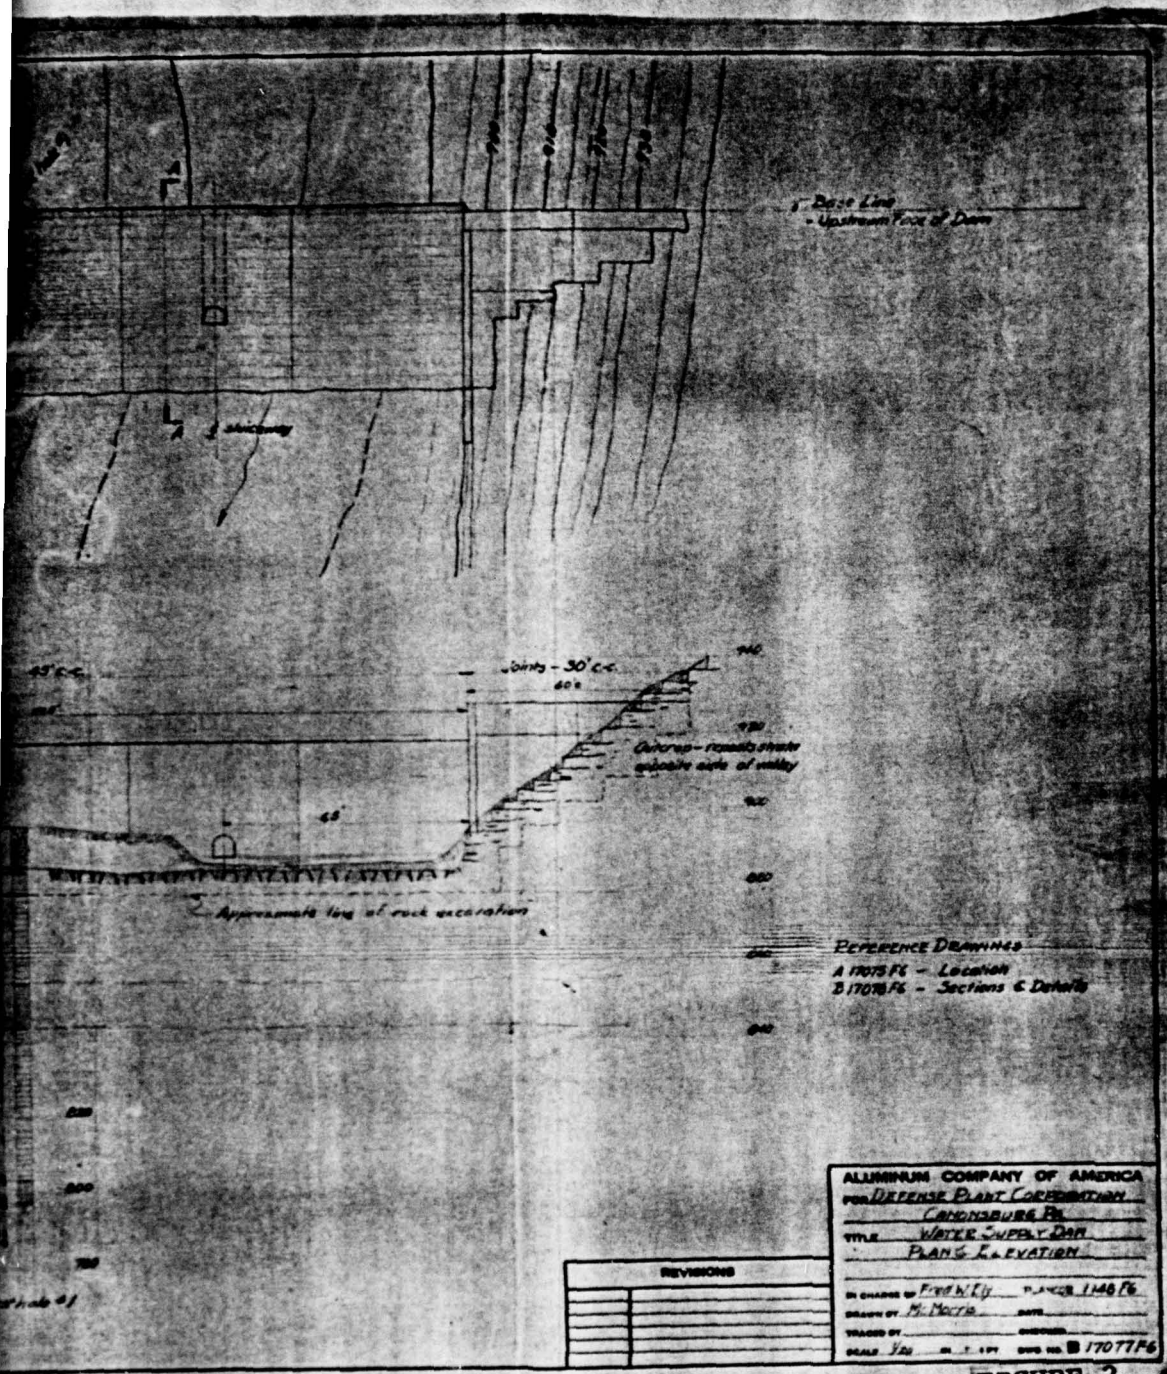
FIGURE 2

Alcoa Dam is founded on a dark shale unit which directly overlies the Uniontown Limestone. Details of the subsurface geology are shown on the attached Figure 2.

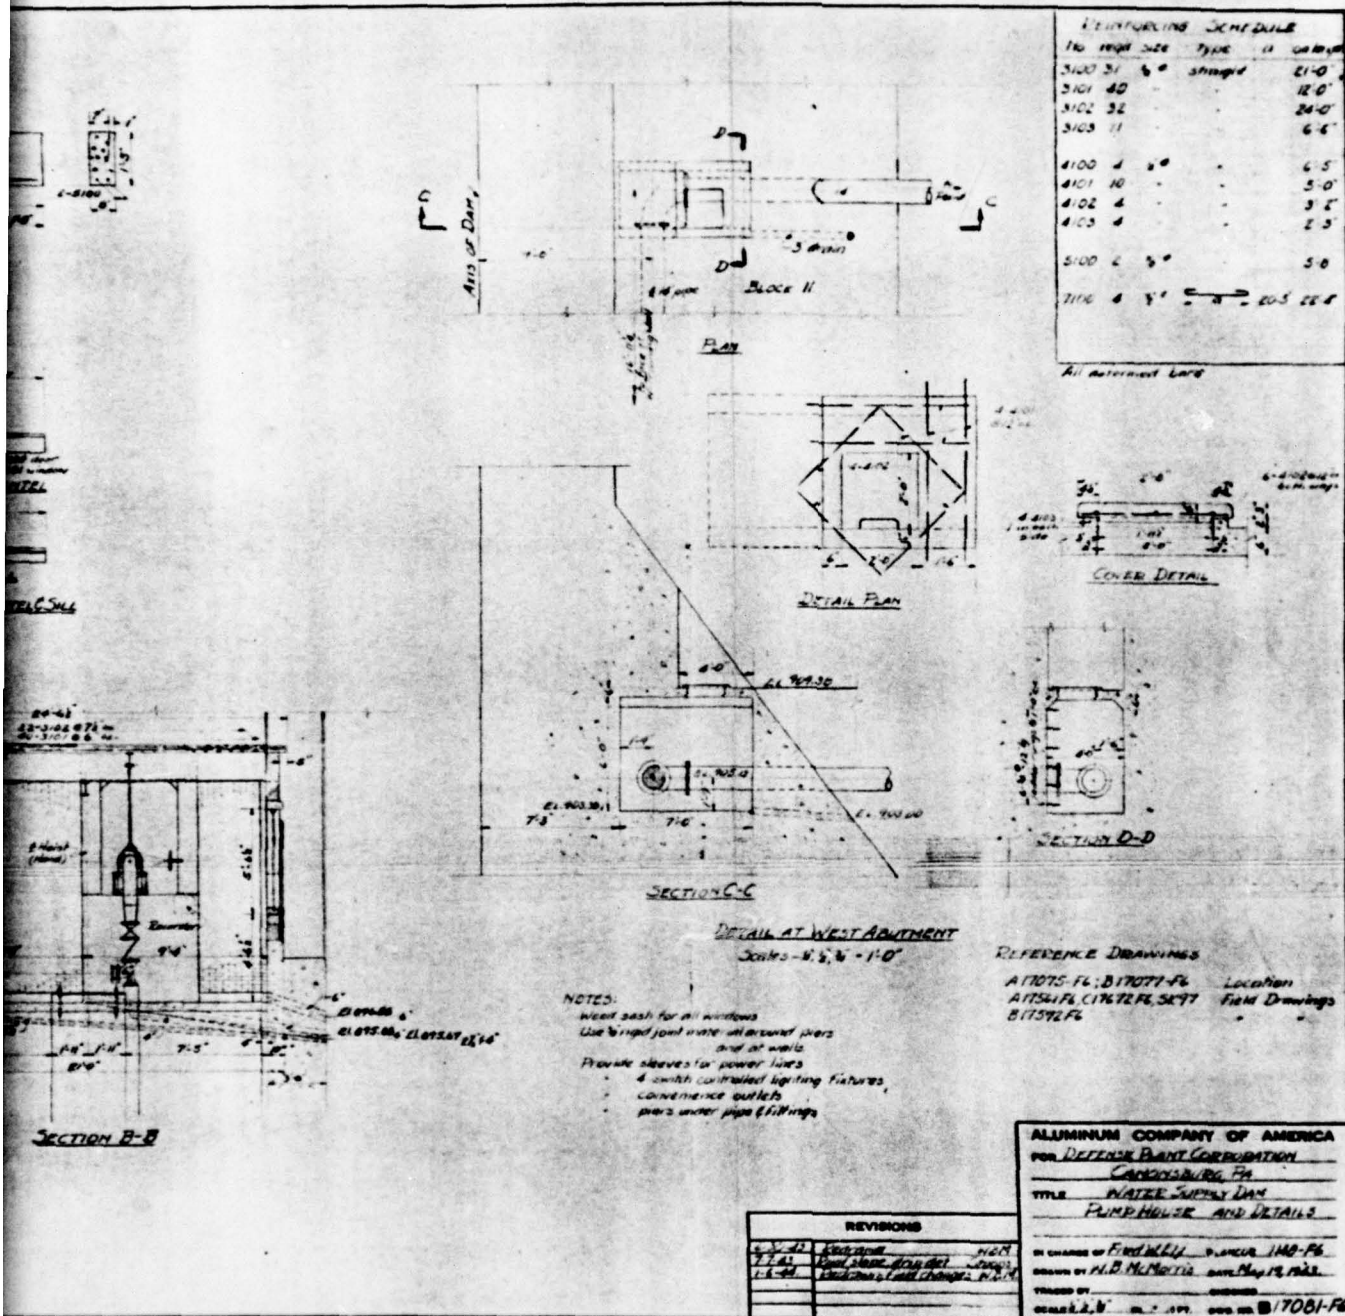
FIGURE 4

b) Pump House. The pump house is located at the downstream base of the dam adjacent to the spillway. It is a one-story masonry structure with dimensions 24 feet by 21 feet. Access to this building was not possible during the visual inspection, consequently, all available information concerning the mechanical equipment it houses is shown on the contract drawings (Figure 4).

The owner's representative was not familiar with the operation of the mechanical equipment in the pump house. Thus, it is recommended that an operating manual and warning system be available for use in the event of a heavy rainfall or emergency.

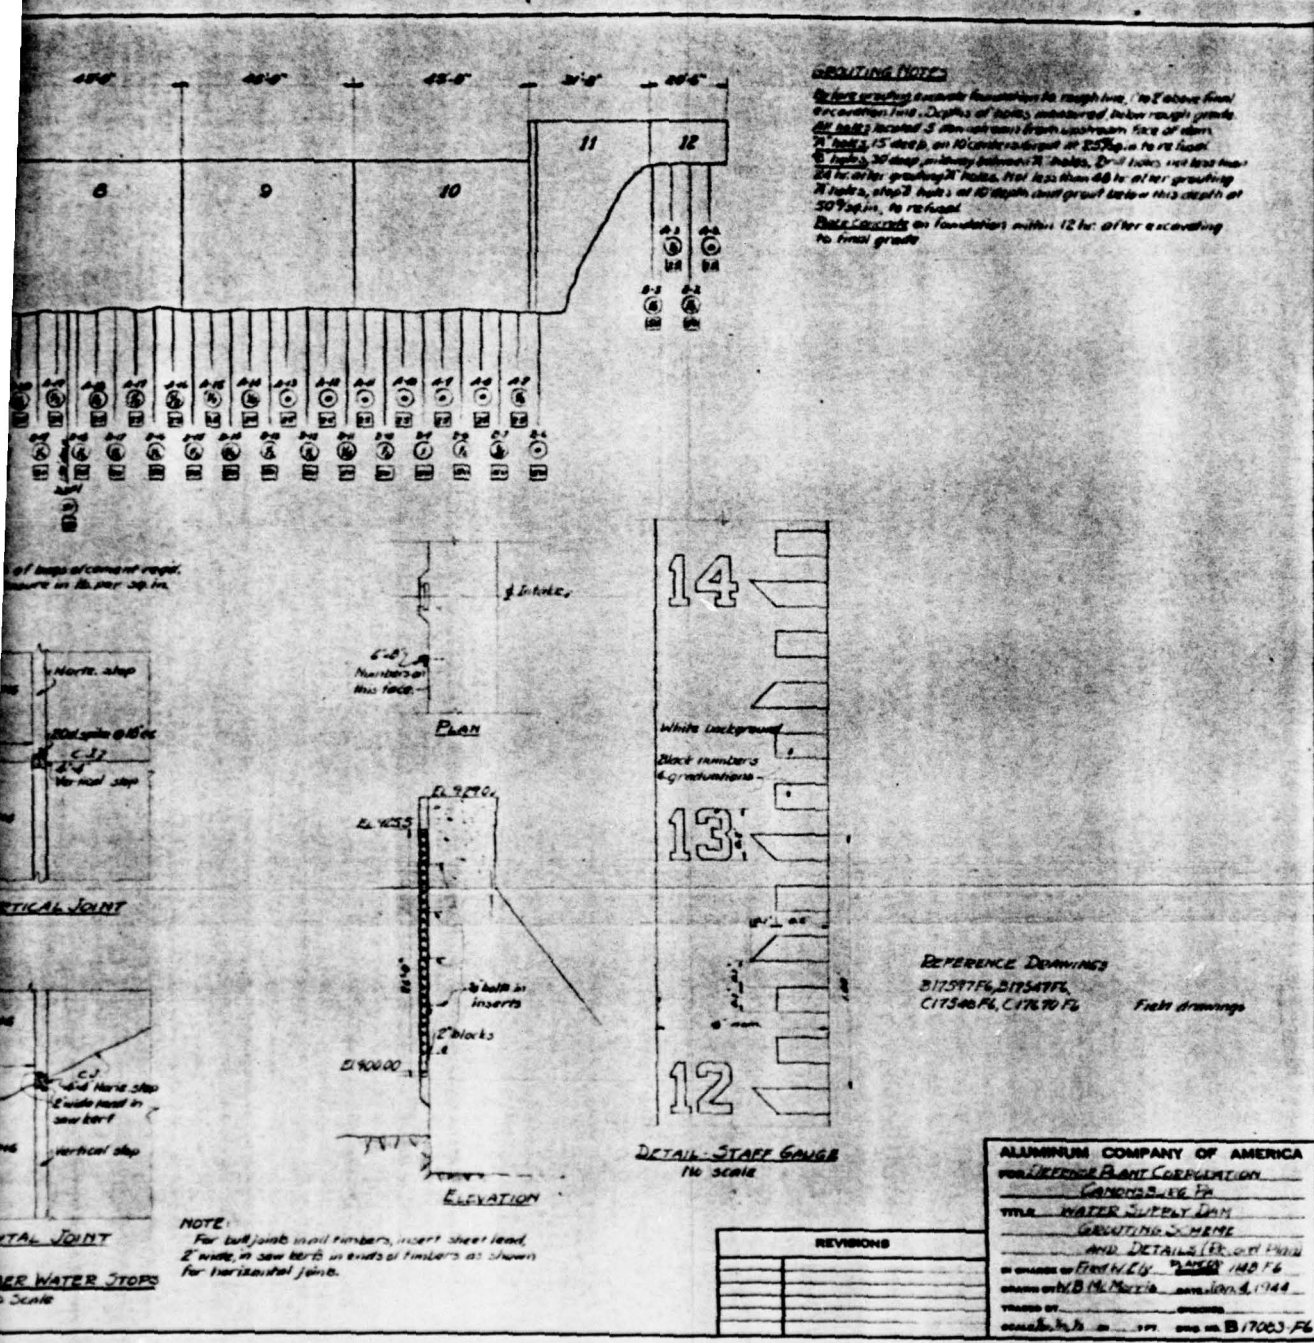
FIGURE 5

can be followed by referring to bi-monthly construction progress reports available from PennDER files (see Figure 5 for grout hole locations).
